## MOLD COUNTER DURABILITY TESTING

### Progressive Components

Date: August 7, 2015  
Author: L. Tavernit  
Report Number: ESP019766P-1  
Client Reference: CAB-0424-A

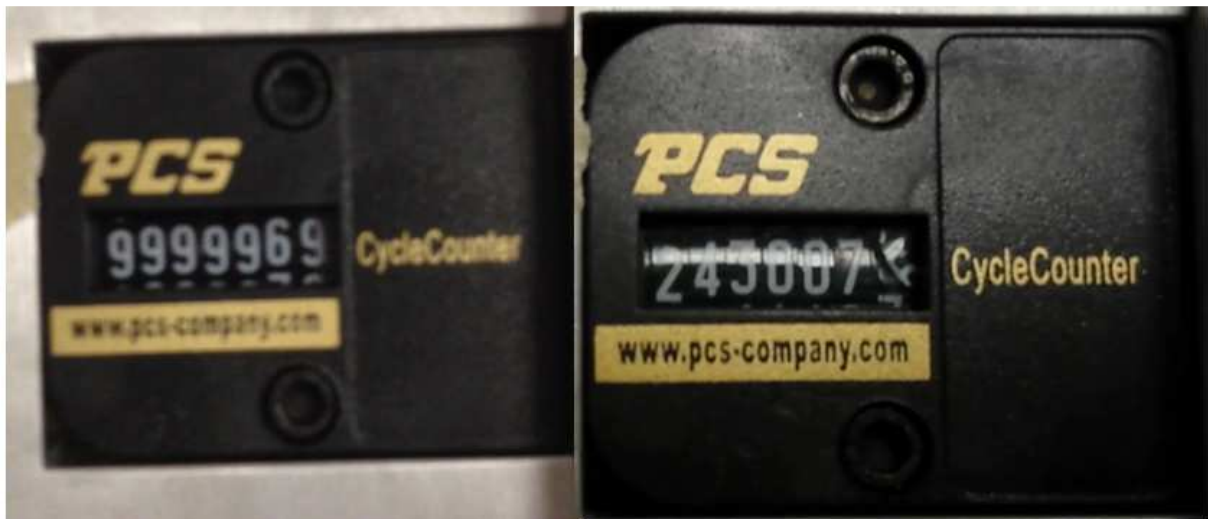
Figure 3 – Counter 2 before and after testing.

Counter Number	Cycles Completed at Failure	Cycles Completed	Failure Type, or Reason for Stopping
1	n/a	3,000,000+	Stopped at 3M cycles, no failure observed
2	22,751	2,529,911	The 10s place was observed to be sitting half way between numbers at 22,751 cycles. Counter stopped advancing at 2,529,911 cycles.
3	n/a	3,000,000+	Stopped at 3M cycles, no failure observed
4	22,805	1,648,994	The 10s place was observed to be sitting half way between numbers at 22,805 cycles. Counter stopped advancing at 1,648,994 cycles.
5	n/a	3,000,000+	Stopped at 3M cycles, no failure observed
6	22,833	3,000,000+	The 10s place was observed to be sitting half way between numbers at 22,833 cycles. Stopped at 3M cycles, no other failure observed
7	n/a	3,000,000+	Stopped at 3M cycles, no failure observed
8	22,864	152,559	The 10s place was observed to be sitting half way between numbers at 22,864 cycles. At 152,559 cycles the counter had counted approximately 8,000 extra cycles. Random skipping was observed.

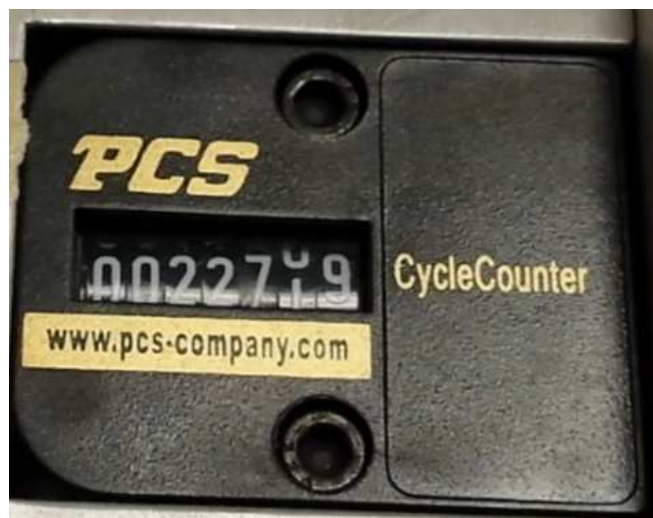
Figure 4 – Counter 2 at failure.

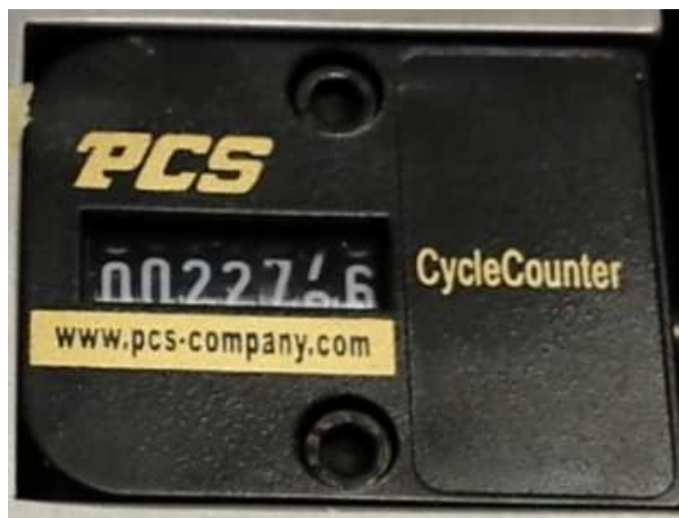
Figure 7 – Counter 4 at failure.

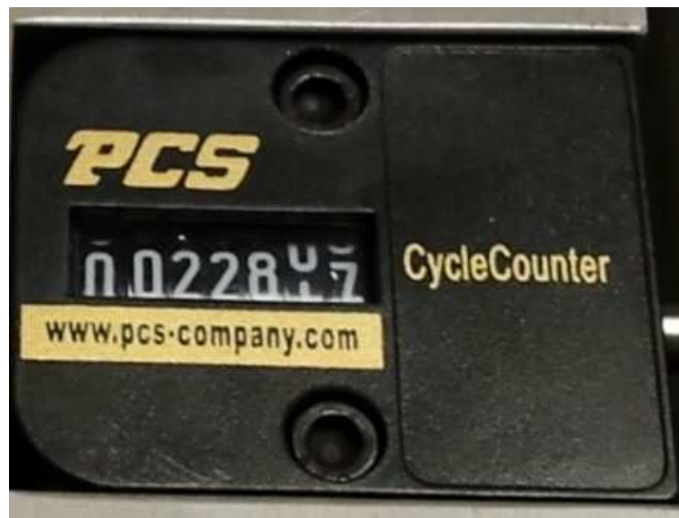
Figure 10 – Counter 6 at failure.

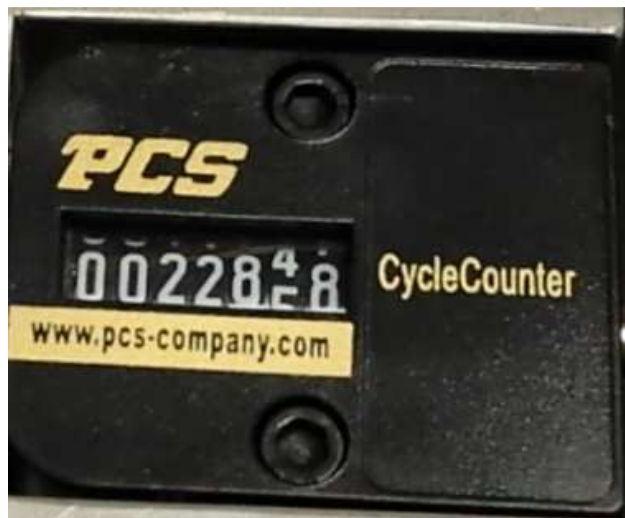
Figure 13 – Counter 8 at failure.
