Progressive Components  
235 Industrial Drive  
Wauconda, IL 60084  
800 269 6653  
Attn: Ken Rumore

L. Tavemit  
ESP016858P-P20-Rev5  
CAB-0516-A

# WEAR TESTING OF EJECTOR PINS

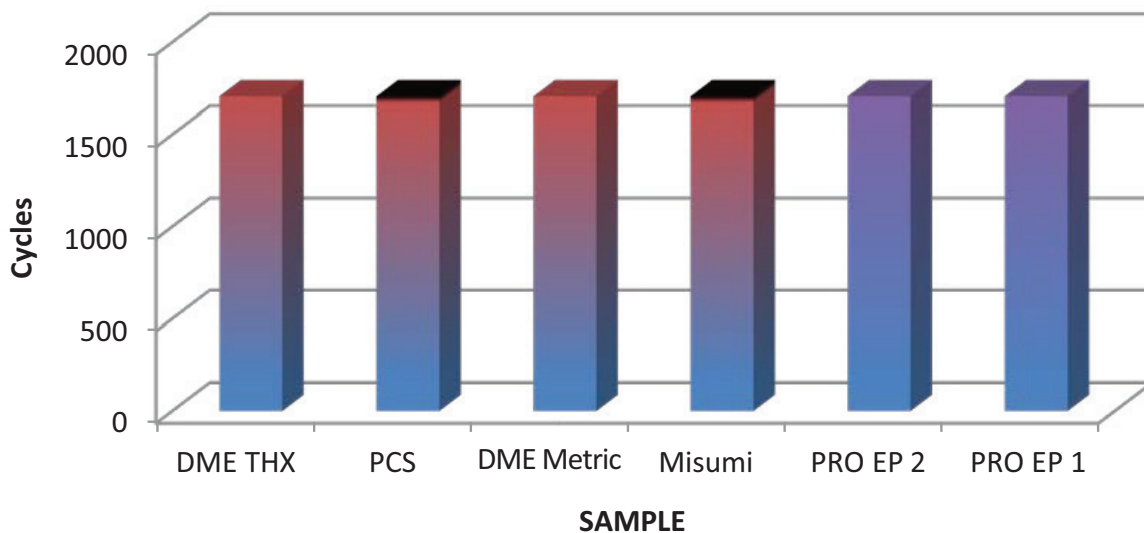
### Ejector Pin Wear Ratings - P20 Jaws

The degree of wear scale, shown on the gradient bar chart (page 3), was defined as follows:

0. No Wear (Blue)
1. Slight wear lines or burnishing present (Slight Wear, Purple)
2. Wear or galling starting (Significant Wear, Red)
3. Heavy wear or galling present (Failure, Black)

DME THX		PCS		DME Metric		Misumi		PRO EP 2		PRO EP 1	
Cycles	Wear	Diameter	Wear	Diameter	Wear	Diameter	Wear	Diameter	Wear	Diameter	Wear	Diameter
0	0	0.2495	0	0.2494	0	0.2355	0	0.2354	0	0.2495	0	0.2493
1706	2	0.2495	3	0.2495	2	0.2355	3	0.2355	1	0.2496	1	0.2494

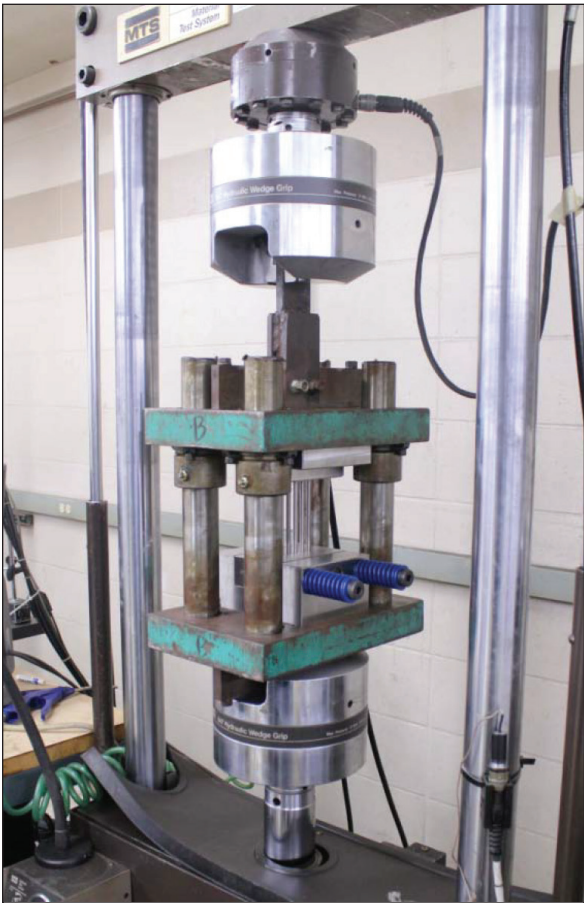
**Figure 1:** Test fixture setup.

The MTS 810 Material Test System was used to cycle the ejector pin samples  $\frac{3}{4}$  of an inch at 1 Hz with a fixture provided by Progressive Components. The fixture consisted of two jaws made of P20 steel that clamped the specimens between them by use of two springs that were tightened in place with shoulder bolts. The samples were not greased. A photograph of the test setup can be seen in Figure 1.

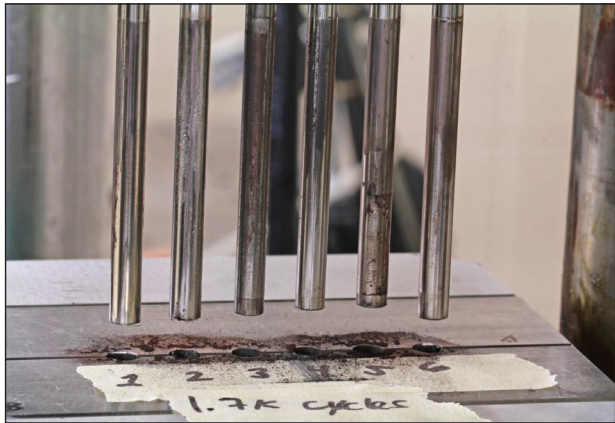
**Figure 3:** Test samples at 1,706 cycles.

- The test was stopped at 1,706 cycles because the load required to move the pins increased to the limit of the test machine.
- Heavy galling was seen on Sample 2 (PCS) and Sample 4 (Misumi) at 1,706 cycles.
- Wear and galling were seen on Sample 1 (DME THX) and 3 (DME Metric) at 1,706 cycles.
- Burnishing of the surface was seen on Sample 5 (Pro EP 1) and Sample 6 (Pro EP 2) at 1,706 cycles. No galling or dimensional loss was observed.
