May 11, 2021 Jay Anderson 69411.1R1 TJI-0420-A

LOAD TESTING OF LIFTERS

Two lifter assemblies were submitted by Progressive Components to Element Materials Technology for load testing, to identify the tensile strength of the lifter assembly. The test compared (2) samples of equivalent sized Progressive C-Series and the DME Accualign lifter assemblies.

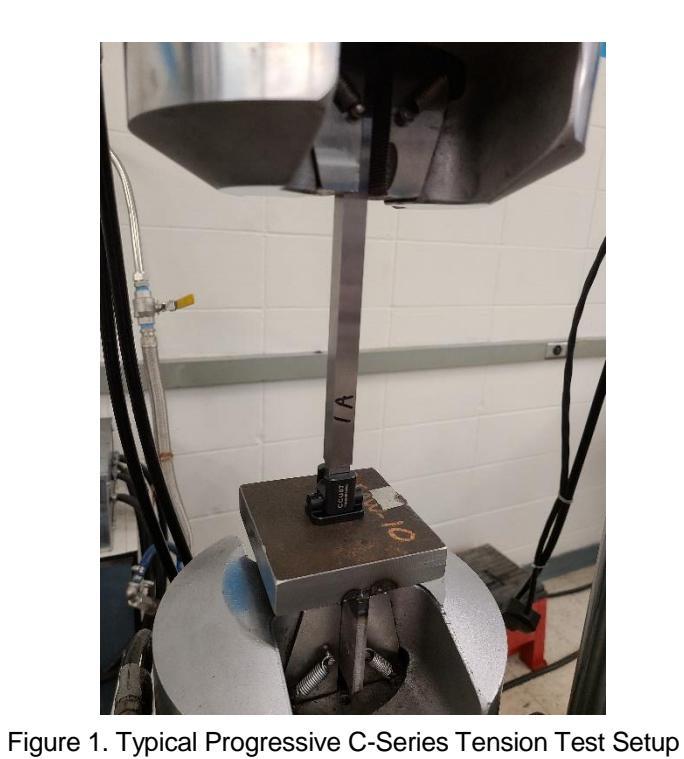
Figure 1.1. Expanded View

Specimens were tested in tension at a speed of 0.2"/min. Typical tension test setups are presented in Figures 1 and 2.

Revision	Page #, Section, Description	Date
0	Original Release	5/10/2021
1	Added Expanded View in Figure 1 and Figure 2	5/11/2021

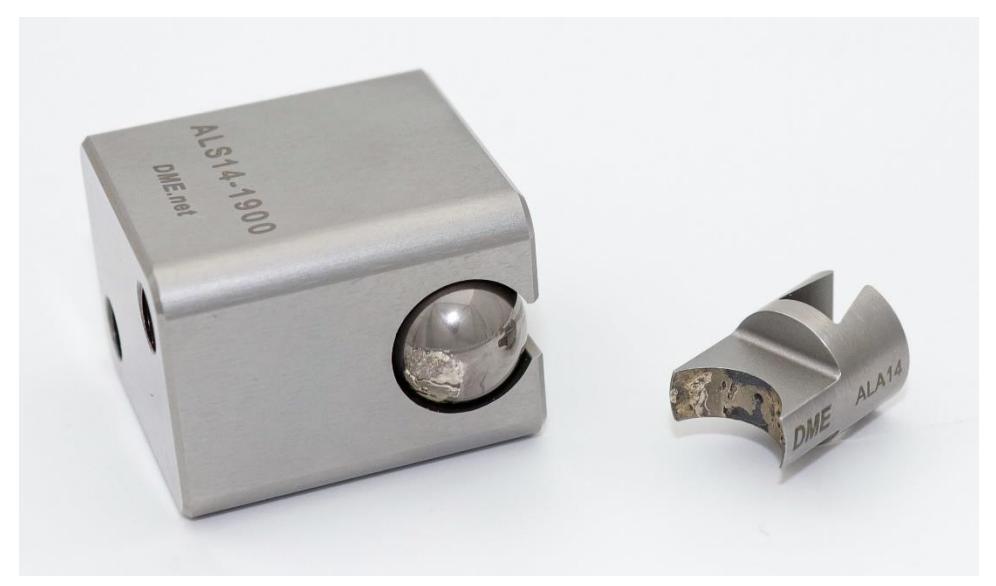
Figure 3. Ball Failure of Specimen 2A, Part # ALA14

The DME Accualign lifter broke at approximately 1/3 of the load that the Progressive C-Series UniLifter was able to withstand.

Peak Load,	
Sample Manufacturer		Specimen	lbf	Location of Failure
C-Series Lifter	Progressive Components	PRO 1A	5,325	Pulled out of Connector Legs, No Fracture
Assembly Part # CCU87		PRO 1B	5,528	Pulled out of Connector Legs, No Fracture
DMF Accualign 500	DME	DME 2A	1,210	Ball (Figure 3)
Series Part # ALA14		DME 2B	1,606	Connector Let at Ball (Figure 4)

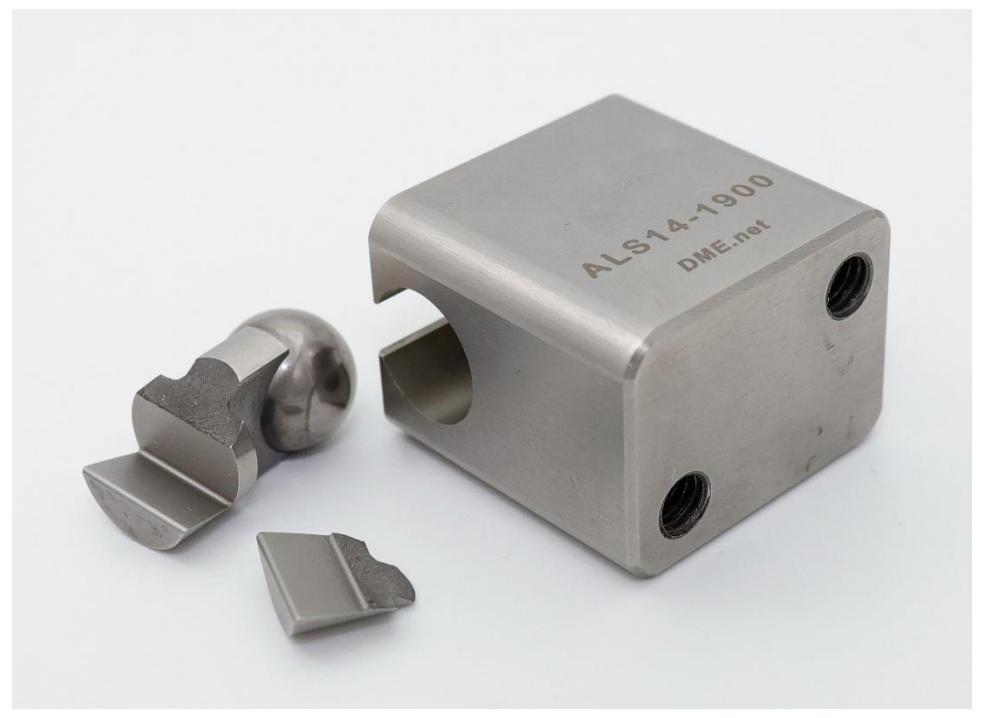
Figure 4. Connector Leg at Ball Failure of Specimen 2B, Part # ALA14
